# Manhole Inspection Summary

Manhole # S51U1\_008MH

Record Plat: **51U1** Node: **008** Status: **New Manhole (Not in GIS)** Insp Date: **6/10/09 1:43 PM**

**Location** Address: **Frankfurst Ave**

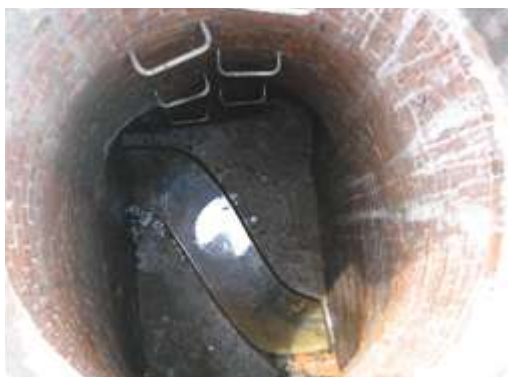
Defect 1

Infiltration: ☐ None ☐ Joint ☐ Cracks ☐ Mortar ☐ Roots ☒ **Wall**

wall infiltration

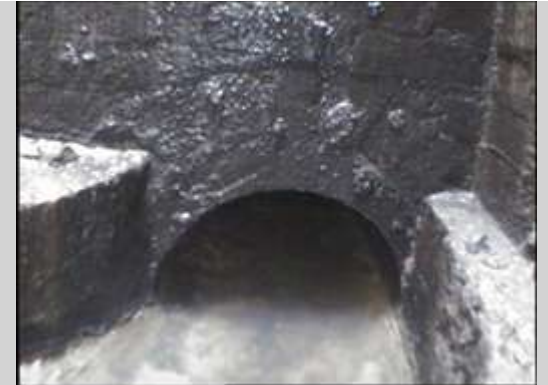
12 O'Clock Outflow

15 in. Circular Gravity Sewer  
Pipe Out @ 12 O'Clock

Pipe Height: **15.6** (in.) Rod and Bar (Angled)  
Pipe Material: **Clay** ☐ Pipe Lined  
Invert Depth: **11.52** (ft.) Flow Characteristics: **Fast**  
Deposits: ☒ None ☐ Mud ☐ Sludge ☐ Debris ☐ Grease  
Silt Depth: (in.) Deposits Extent:  
Infiltration: **None** Pipe Seal Cond: **Sound**

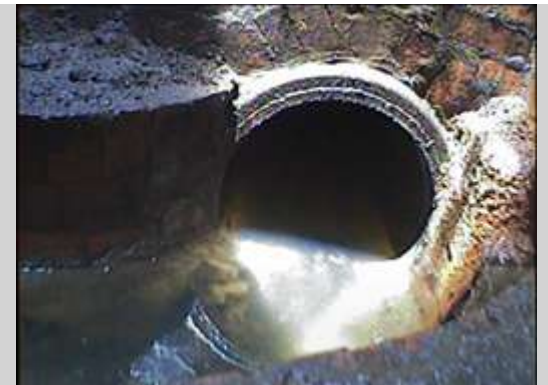
6 O'Clock Inflow

12 in. Circular Gravity Sewer  
Pipe In @ 6 O'Clock

Pipe Height: **15.6** (in.) Rod and Bar (Angled)  
Pipe Material: **Clay** ☐ Pipe Lined  
Invert Depth: **11.60** (ft.) Flow Characteristics: **Fast**  
Deposits: ☒ None ☐ Mud ☐ Sludge ☐ Debris ☐ Grease  
Silt Depth: (in.) Deposits Extent:  
Infiltration: **None** Pipe Seal Cond: **Sound**
